Introduction

Appendix 1. Chaleur Bay Watersheds Group Annual Report, 2002-2003.

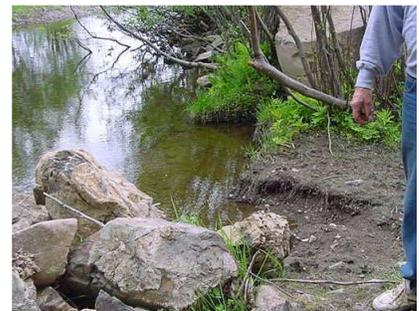
Figure 1. Trampling of riparian vegetation along Grants Brook caused by dairy cattle entering the water-course.

Although disappointed, the group quickly redirected their focus and came up with an alternate project that would be equally beneficial to the environment. This project entitled the “Grants Brook Farm, Cattle Fencing Project”, which was partially funded by the Agricultural Environmental Management Initiative, included leaving a 10-meter riparian buffer strip along the rivers edge, planting 3,000 tree seedlings, installing electric fence and providing the cattle with an alternative source of drinking water. This program was implemented with the goal of reducing sedimentation, bacteria levels and to help maintain cool water temperatures. Water quality monitoring will continue over the next fiscal year to determine the effectiveness that this project has had on protecting water quality.

Although not quite as significantly damaging to water quality and fish habitat as the Armstrong Brook Cattle Crossing Project, the Grants Brook Farm project will have a significantly positive influence on water quality. The group hopes that by showing other stakeholders that their intention is to work cooperatively with landowners in order to protect and improve water quality that they might be more likely to become involved in future projects. The CBWG feels that this project will have far reaching benefits for the environment beyond just improving water quality. In fact, other landowners have already contacted us in hopes of being involved in implementing future best management initiatives.

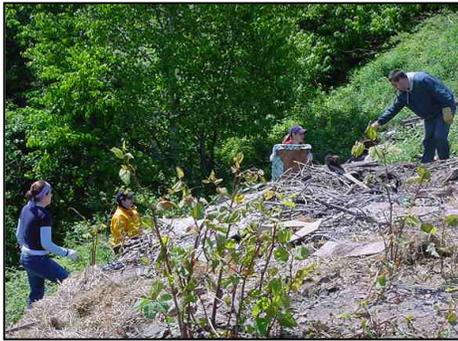
Figure 2. Armstrong Brook during Stream Clean-up, 2002.

An illegal dumping site located adjacent to Armstrong Brook was identified as one of the action items for the Armstrong Brook watershed during the provisional classification exercise. After a plan was developed with technical assistance from the Department of the Environment and Local Government, Municipality of Belledune several logistical arrangements were made and, a clean up event was scheduled for June 15, 2002. Although the event only had six participants, the outcome was very successful. In all, a total of 94 bags of garbage were removed with a total weight of 1,670 kg. Due to the overwhelming success of this clean up, other stream clean up activities will likely take place in future years at this site and in other locations throughout the watershed. The event was featured in articles in newspapers from both the Bathurst and Restigouche area. This helped to increase awareness of the general public regarding the severity of illegal dumping as well as to promote the hard work of the community members who took part. Signs provided by the regional office of the Department of Environment and Local Government were posted at this site and at other known dumping sites to deter further illegal dumping.
